FLUOR DANIEL GTI

June 2, 1998

**RE: SCE&G - CPA Site
South Carolina Aquarium Parking Garage Construction
Foundation Pile Placement, Wick Drain Installation, & Pile Driving**

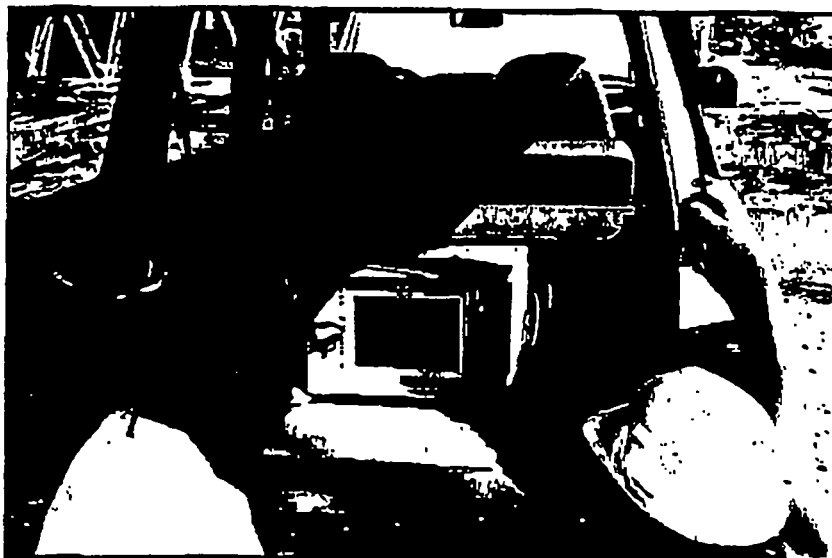
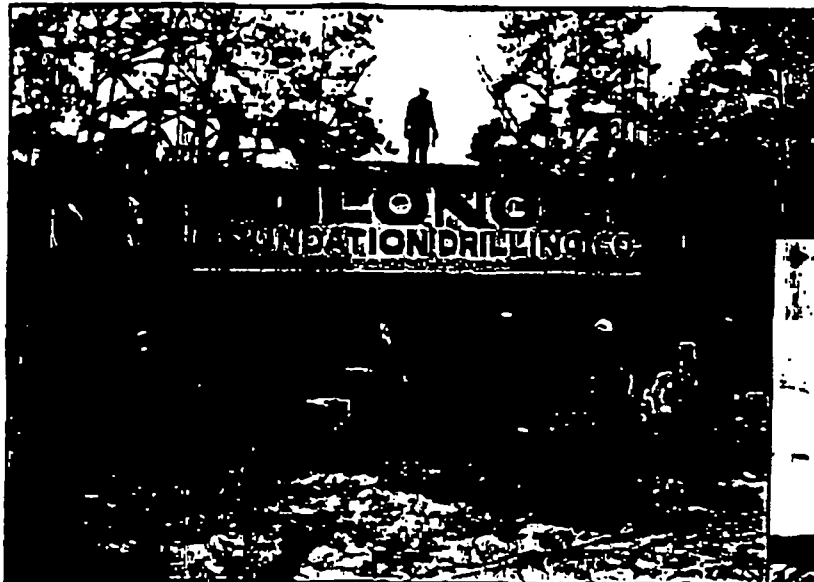
*Typical static load test requirements:
crane, reaction system, jack, pile hammer,
reference beams (above)*

*and equipment needed for dynamic testing:
crane, pile hammer, and PDA (right).*
